Seeking workable solutions to insulation and moisture control in traditional Welsh dwellings.

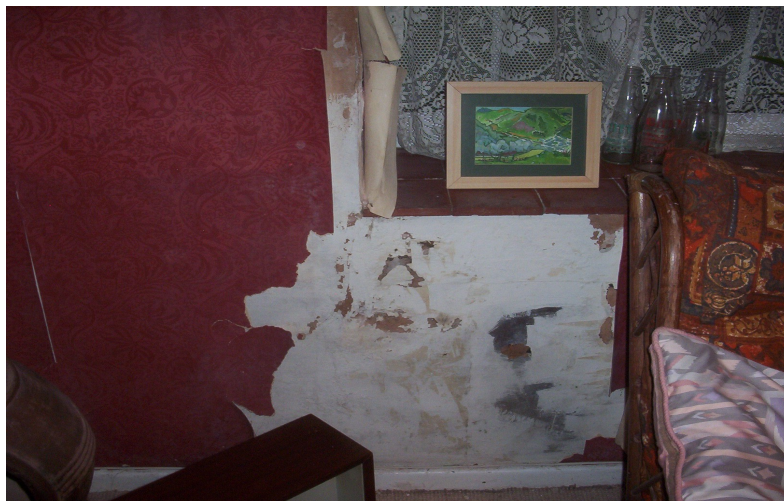
Figure 2 *Internal wall of sitting room. Cement rendered.*(Photo [lifespacedesign](#) 2009)

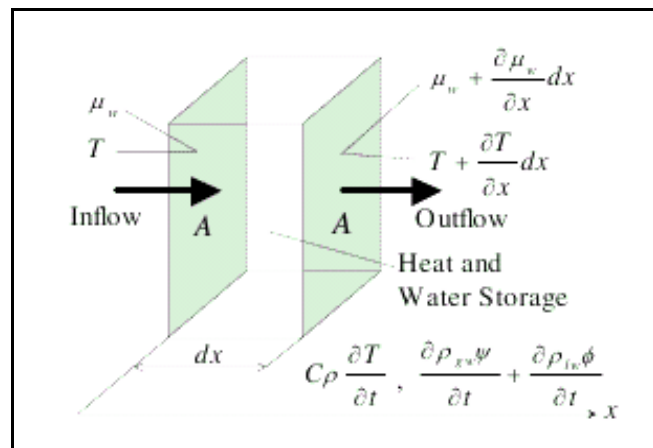
Figure 4 Typical Conductive heat and moisture transfer model ([Ozaki and Tsujimaru 2005](#))

The core equations offered by the modelling software are critically dependant on the various coefficients for moisture and heat transfer through the section as well as the assumption of homogeneity. The modelling tools examined so far treat any given masonry wall element as a uniform homogeneous material (figure4) and therefore would struggle to accurately model the true case of this type of building. Given these limitations and lack of time, it was not appropriate to apply a numerical modelling tool to this case.

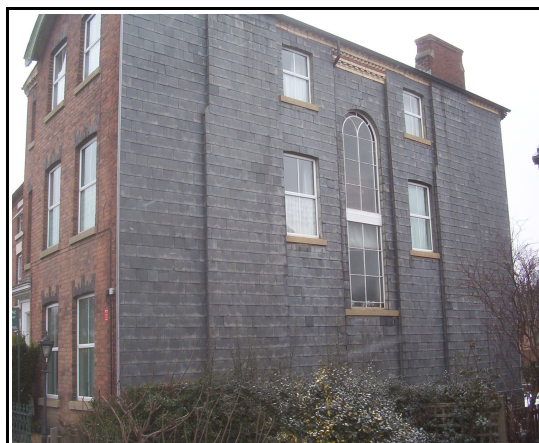
Figure 6. Slate hung exposed elevation; (photo; [lifespacedesign](http://lifespacedesign.com) 2009)

Such a solution would effect both the fabric and visual appearance of the building so may well be forbidden in the case in point. If permitted this solution would open the option of external application of insulation materials, but would not be applicable to the other elevations. Insulation solutions allowing moisture to pass, such as hemp/lime composites could only be applied here if the other moisture issues were solved.

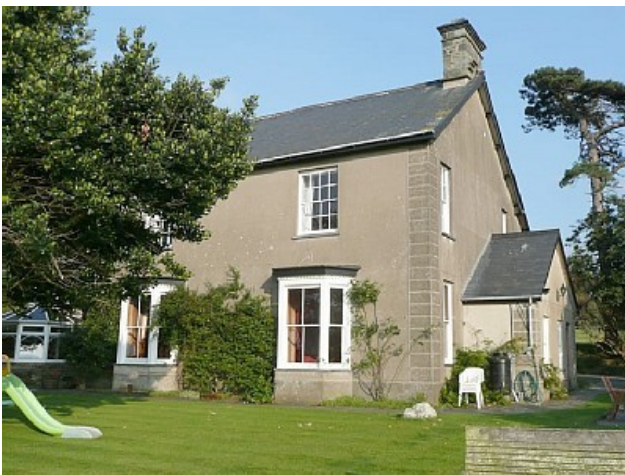
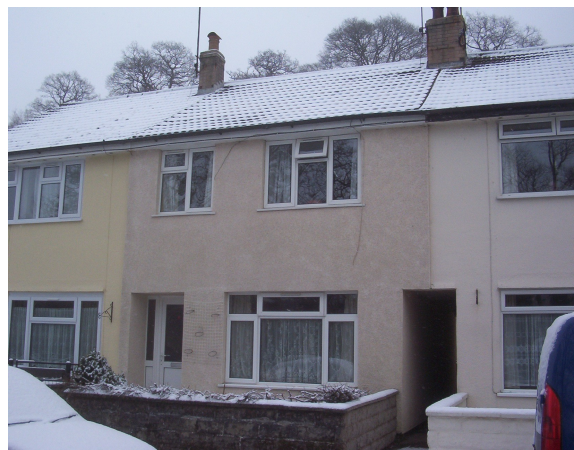
Figure 8 *Cement rendered traditional dwellings ([Holiday Rentals](#)) left and insulated houses right (photo- [lifespacedesign](#)) Two of the three houses in this terrace have 50mm foam external insulation, can you tell which?*

External insulation could be applied simultaneously without damaging the landscape value of the dwellings, as demonstrated by the example of a terrace of houses in figure 8. As always this is only applicable where rising damp from groundwater can be eliminated first. Making these homes comfortable at reasonable energy cost is crucial to their continued year round occupation, providing accommodation for a local workforce and their families. In order to achieve their social agenda to maintain the Parks as living communities the
